# Manhole Inspection Summary

Manhole # S47G\_\_008MH

Insp Date: **5/1/08 11:46 AM**

**Location** Address: **2044 S Chester St**

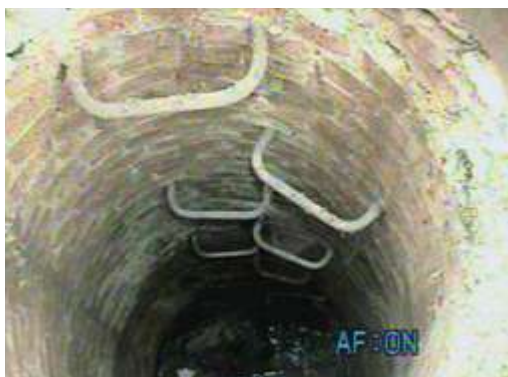
Defect 2

Count: **8** Missing: **0** ☒ **Corroded**

corroded steps

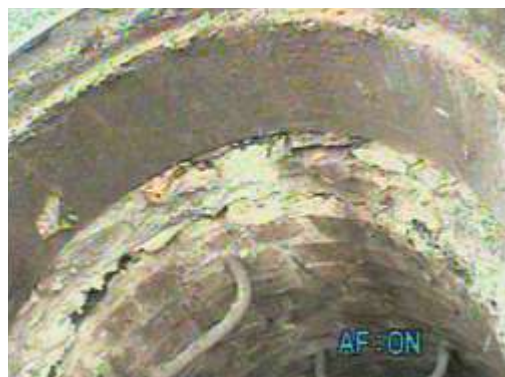
Defect 1

Condition: ☐ Sound ☐ Cracked ☐ Root Intrusion ☐ Loose Brick ☒ **Deteriorated**

deteriorated frame adjustment

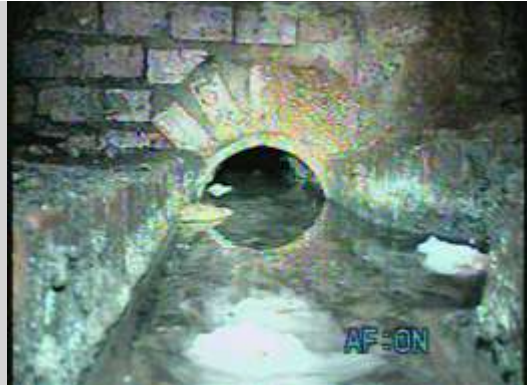
12 O'Clock Outflow

8 in. Circular Gravity Sewer  
Pipe Out @ 12 OClock

Deposits: ☐ None ☐ Mud ☐ Sludge ☒ Debris ☐ Grease

Silt Depth: 4 (in.) Deposits Extent: Medium

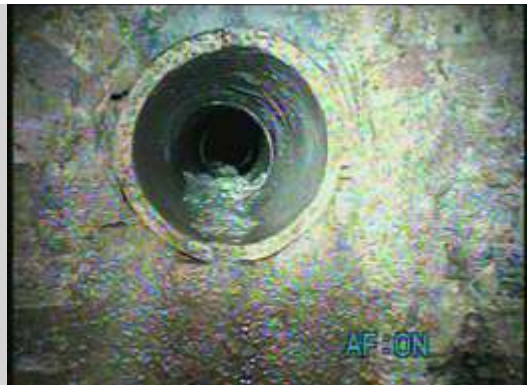
3 O'Clock Inflow

8 in. Circular Gravity Sewer  
Pipe In @ 3 OClock

Deposits: ☐ None ☐ Mud ☐ Sludge ☒ Debris ☐ Grease

Silt Depth: 3 (in.) Deposits Extent: Medium

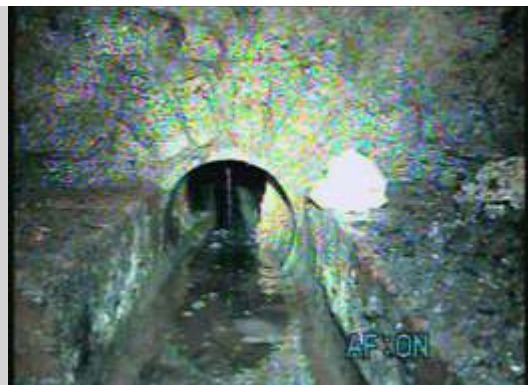
6 O'Clock Inflow

8 in. Circular Gravity Sewer  
Pipe In @ 6 O'Clock

Deposits: ☐ None ☐ Mud ☐ Sludge ☒ **Debris** ☐ Grease

Silt Depth: **2** (in.) Deposits Extent: **Medium**
